Agreement No. CE 35/2006 (CE)

# Kai Tak Development Engineering Study cum Design and Construction of Advance Works - Investigation, Design and Construction

**Further Archaeological Excavation Report**

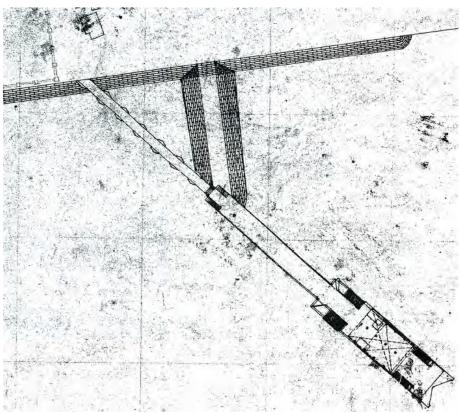
Figure 13 Kowloon City Pier and Its 1930's causeway (Mapping Office of Lands Department, original scale 1:600)

- 5.3.4 The 1930s' causeway is noted in a map of Former Kowloon City Pier (**Figure 13**). Causeway survives beneath the Kai Tak Airfield reclamation of 1942 to 1945 and a sloping wall of huge granite blocks (each measured 2.2m x2.2m) has been exposed.

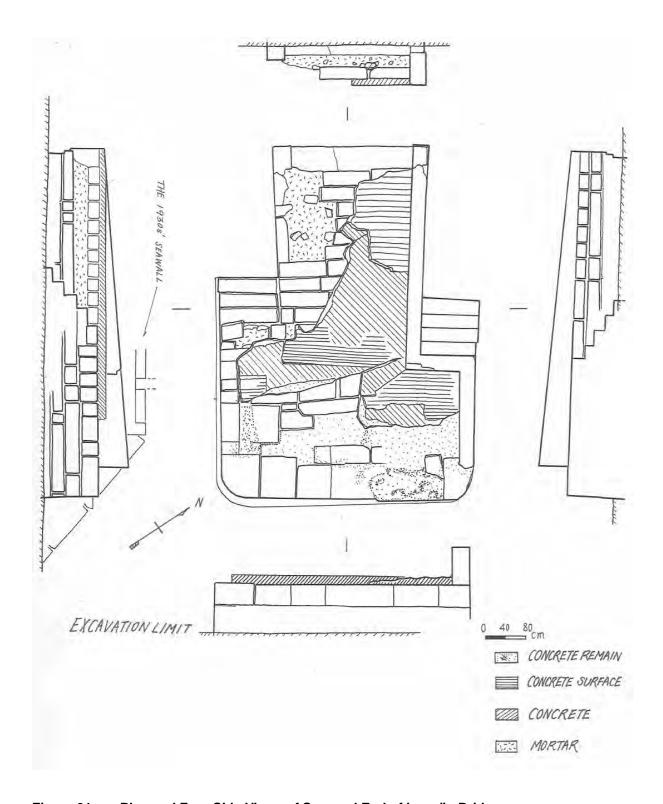
Figure 31 Plan and Four Side Views of Seaward End of Longjin Bridge

- 5.3.13 The seaward end exhibited some evidence of two historic modifications as follows:
  - timber extension was modified to concrete extension in 1910 (details refer to Section 4.4);
     and
  - construction of Former Kowloon City Pier in the 1920s.
- 5.3.14 The two historic modifications are reflected by three different concrete layers observed at the decking surface of the seaward end as follow:
  - the first layer is the original decking surface of the seaward end;
  - the second layer is a subsequently paved concrete layer; and
  - the third layer is a concrete ramp connected to the new ferry pier extension Former Kowloon City Pier (Figures 30 to 33).
- 5.3.15 Some evidences of repairing by cement were also observed at the landing steps and decking surface of the seaward end (**Figures 28, 31** and **33**).

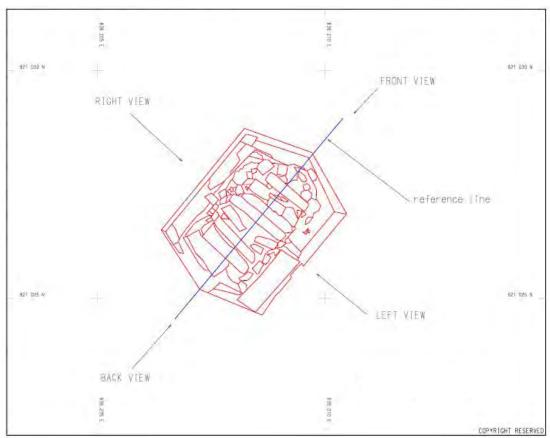
Figure 36 Plan of Supporting Pillar SP6 of Longjin Bridge

- 5.5.1 In order to assess the existing condition of SP6, an additional grid was excavated inside T1 down to the base of the pillar foundation (**AF 1.4**). Steel sheet piling was adopted around the additional grid to prevent collapse of the grid (**Figures 35** to **46**).

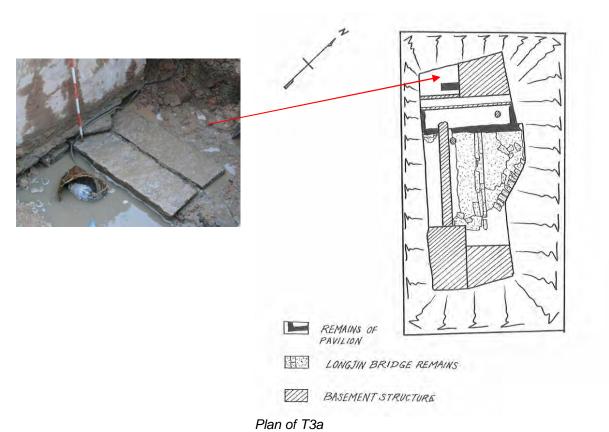
Figure 63 Two Granite Slabs of Pavilion for Greeting Officials

- 5.6.8 The floor of the Pavilion was not discovered and a layer of grey marine sand was found below the anticipated level of the Pavilion floor (**Figure 63, AF1.9**). Two discrete granite slabs were also found within the anticipated location of the Pavilion and the function of these two granite blocks is uncertain.

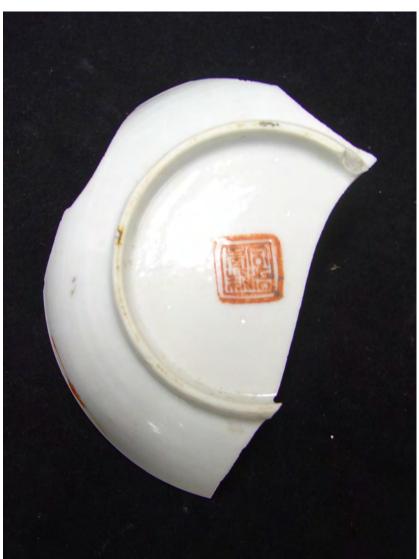
Figure 69 Porcelain Plate With Make of Reign of Tongzhi (同治年製 1862-1873)

- 5.6.9 A datable artefact was found in the marine sand layer inside the site of the Pavilion. It is a broken porcelain plate with seal of "Made in the Reign of Tongzhi (同治年製)" written in minuscule script writing style<sup>17</sup> (**Figure 69**). The Bridge was built in 1873 (the 13<sup>th</sup> year of Tongzhi Reign) which is consistent with the time span of manufacturing of this datable artefacts.
